Technical Report

Cyclic Load Testing of Unreinforced Masonry Walls

Daniel P. Abrams and Nirav Shah

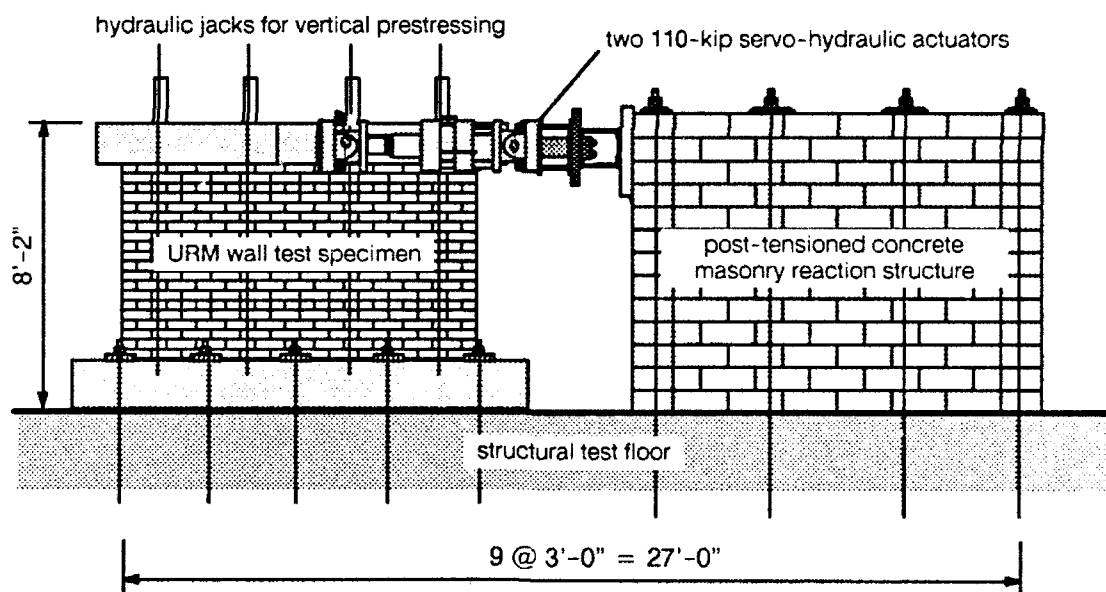
A typical wall in the loading rig is shown in Figs. 2.1 and 2.2. The boundary conditions at the top and bottom of a wall test specimen emulated a cantilevered element, with both vertical and horizontal loading applied at the top of the wall. Horizontal forces were applied at the center-

Figure 2.1 Loading Rig and Wall Test Specimen

line of a test wall using a twin pair of 110-kip capacity servohydraulic actuators that were reacted against a stiff post-tensioned concrete masonry reaction structure. Details on construction and utilization of the reaction structure can be found in Ref. 18. Vertical compressive forces were applied at the top of a wall specimen with a series of four pairs of hydraulic jacks. The jacks were reacted with steel prestressing bars that were anchored into a concrete foundation pad. Vertical forces were applied on the top of a concrete beam (Fig. 2.3) that distributed the forces to the top of a wall specimen evenly. The concrete beam was also used to distribute horizontal forces.

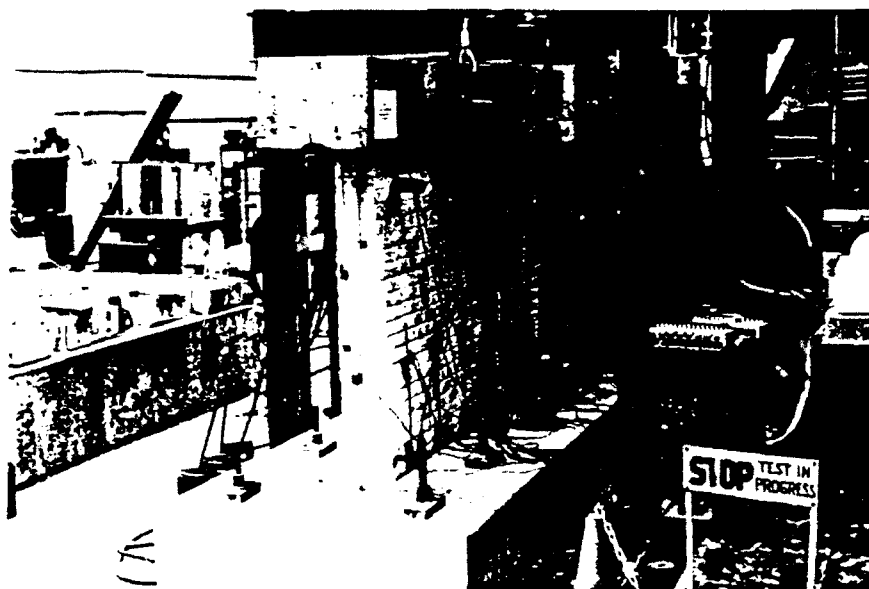
Figure 2.2 Test Wall in Rig

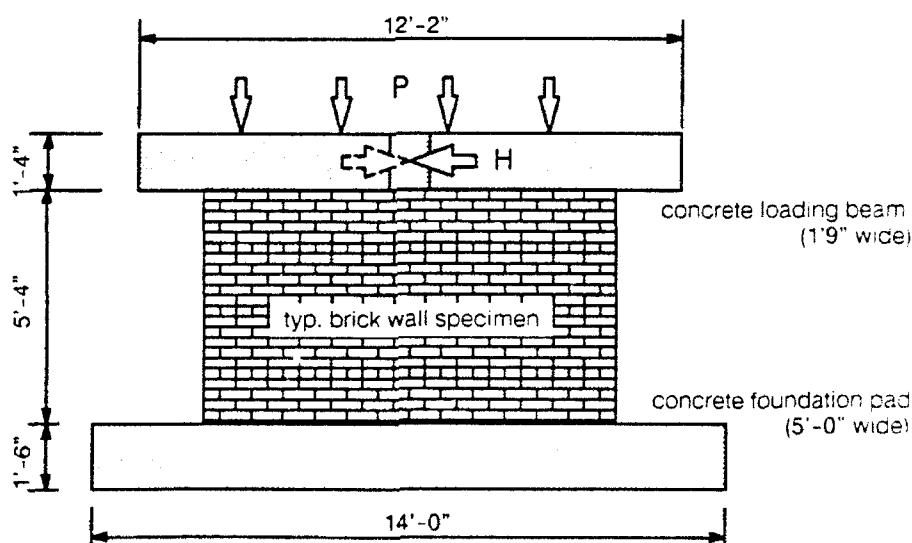
The concrete foundation pad was prestressed to the strong floor so that it would not slide. Ten (1.75" diameter) Dywidag steel prestressing bars were used to clamp the pad to the floor. Dabs of hydrocal were placed at the pad-floor interface to verify that the base did not slide during a test. Since no cracking of the hydrocal was observed, it is certain that the base did not slide. The foundation pad was 14'-0" long and had a rectangular section with dimensions of 60" by 18". The beam was reinforced with #7 bars in both longitudinal and transverse directions.

Figure 2.3 Loading Beam and Foundation Pad

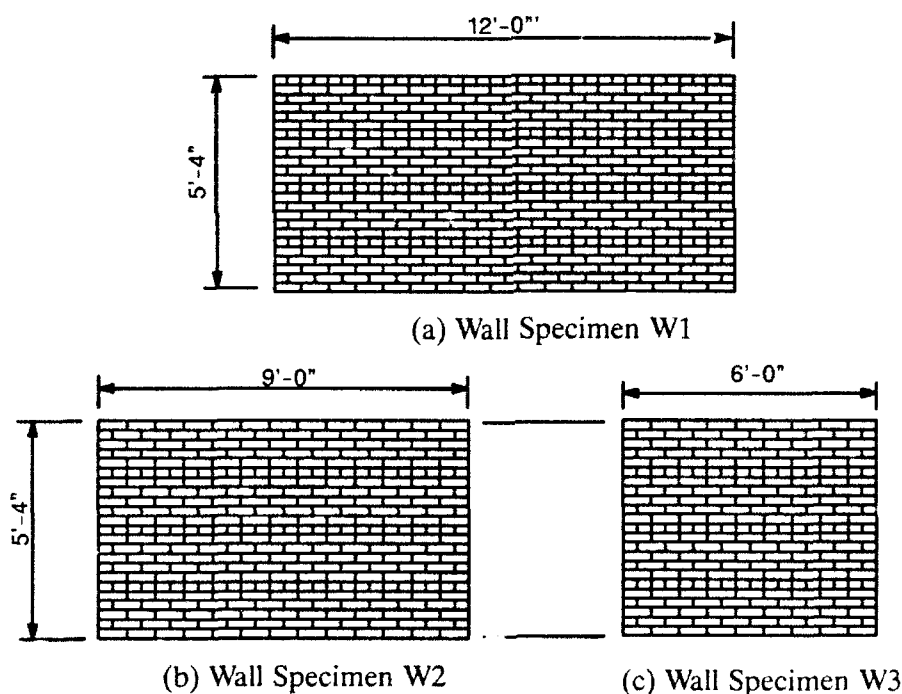
Figure 2.4 Description of Wall Specimens

height was kept the same so that the loading system did not have to be altered, the length of each test wall was varied from 12'-0" to 9'-0" to 6'-0" to give aspect ratios of 2.0, 1.5 and 1.0 for test walls W1, W2 and W3 as shown in Fig. 2.4. A summary of specimen properties is given in Table 2.1.

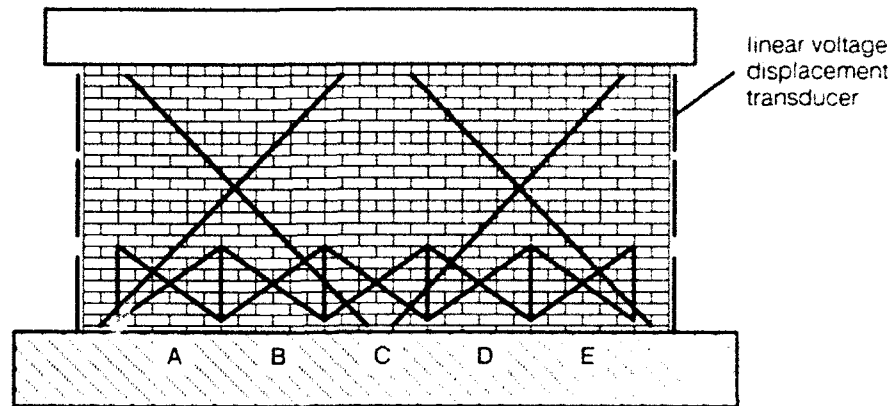
where γ is the calculated shear strain across a specified gage length; δd_1 and δd_2 are the measured deformations along the diagonals (elongation is positive for δd_1 and contraction is positive for

Figure 2.5 Arrangement of Displacement Transducers on Wall Surface

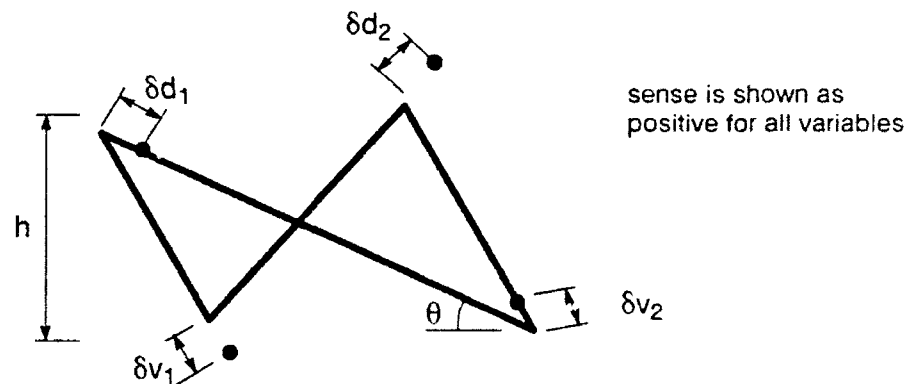
δd_2); δv_1 and δv_2 are the measured deformations along the verticals (contraction is positive for δv_1 and δv_2); θ is the angle formed by the diagonals and the horizontal, and h is the height of the wall along which vertical deformations was measured. These variables are shown in Fig. 2.6. The distribution of shear strain can be visualized by plotting the deduced shear strain at each of the five gage points.

Figure 2.6 Nomenclature for Eq. 2.1

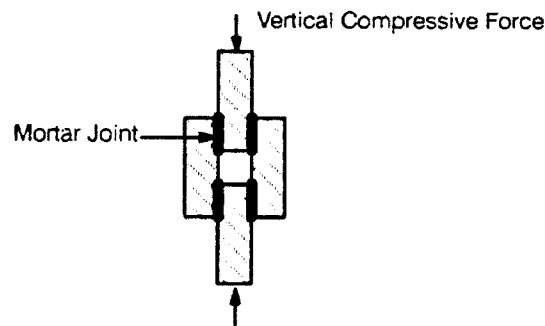
Quadlets as shown in Figure 2.7 were tested for shear strength. A total of nine quadlets were

Figure 2.7 Typical Quadlet Test Specimen

built with the three types of mortar. Because of its zero tensile strength, quadlets made out of lime mortar broke apart upon lifting. The average shear strength was found to be 56 psi for Type N mortar with 49% c.o.v. and 83 psi for Type O mortar with 45% c.o.v. Because of the high data scatter, results of quadlet tests were not given much consideration.

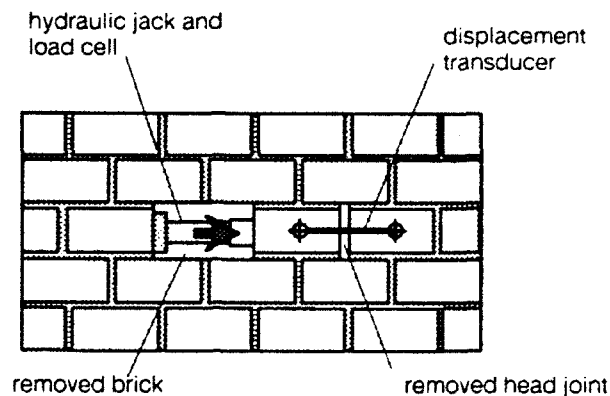
The in-place shear test is a nondestructive test procedure which measures the strength along the brick-mortar interface of a single brick. A brick unit is pushed in the horizontal direction within the plane of a wall until a sliding movement is sensed (Fig. 2.8). The shear strength is then esti-

Figure 2.8 Schematic Description of Shove Test

mated as the peak shove force divided by the area of the resisting mortar joints with the amount of gravity stress at the location of test brick being subtracted.

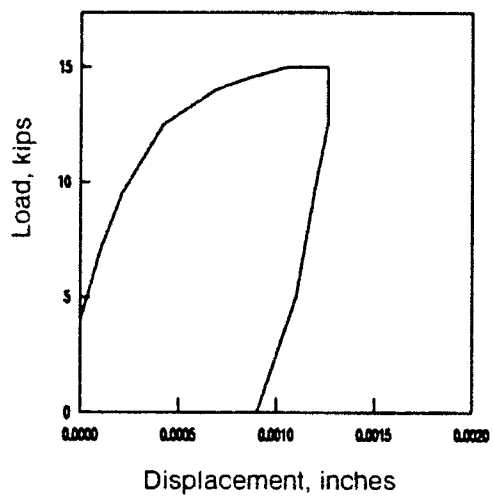
Figure 2.9 Typical Shear Force-Deflection Curve for Shove Test

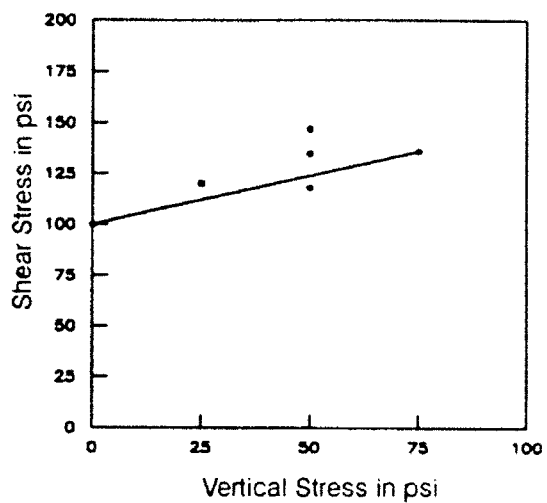
where τ = shear strength; c = cohesion coefficient; σ_v = vertical compressive stress; θ = friction angle. Since the vertical stress, σ_v , could be controlled using the test apparatus, various combinations of normal stress and shear strength could be identified. Results of nine of these tests are summarized in Fig. 2.10 where measured shear stress is plotted versus the known vertical stress. Analysis of the test data reveals an average value of cohesion equal to 100 psi and a coefficient of friction equal to 0.50.

Figure 2.10 Relation between Shear and Vertical Compressive Stress

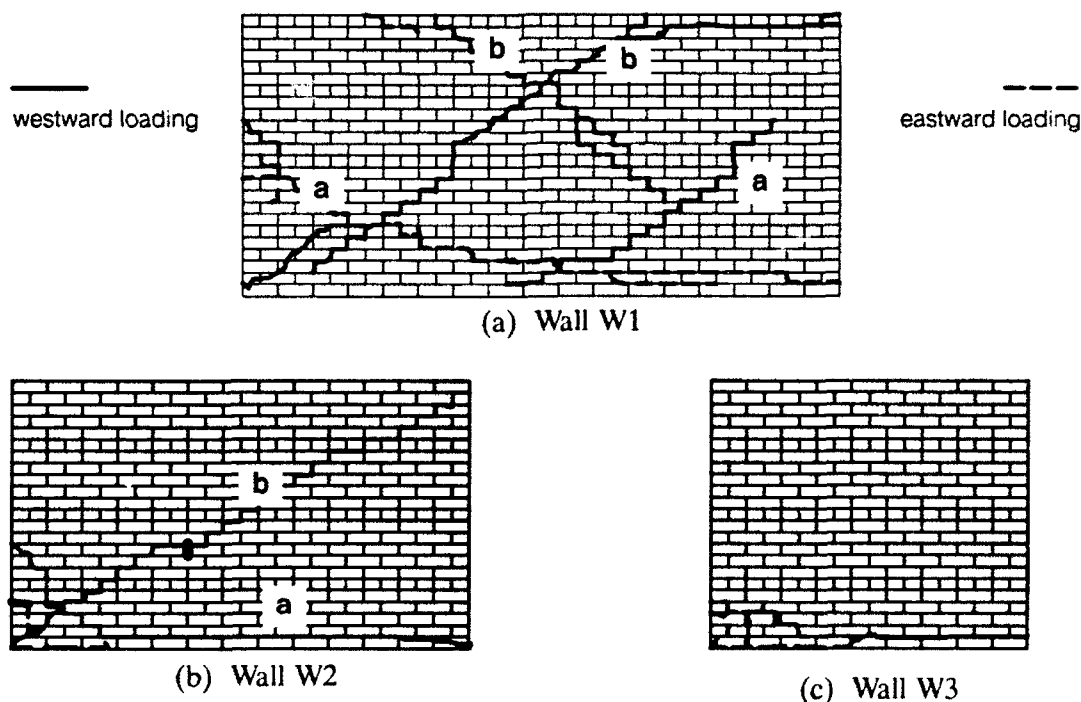
The first wall, W1, failed in shear with no flexural cracking. This was expected since the wall was stocky with an aspect ratio of 2.0. At a lateral force equal to approximately 62% of the ultimate load, a stair-step diagonal crack (marked with the letter *a* in Figure 3.1a) was observed. A second diagonal crack (marked with the letter *b*) was observed just as the test wall was reaching its peak lateral strength. The ultimate limit state for specimen W1 was diagonal shear cracking. It should be noted that the limit state was reached after the second diagonal crack formed. This suggests that a considerable redistribution of shear stresses had occurred after formation of the first crack, and refutes the generally accepted opinion that behavior of unreinforced walls in shear is always a brittle phenomenon.

Figure 3.1 Observed Cracked Patterns

The second wall, W2, being less stocky than the first, and subjected to a lighter vertical compressive stress, cracked initially in flexure. A horizontal crack along the bed joint immediately above the bottom course was observed along approximately two-thirds of the base (marked with

the letter *a* in the Figure 3.1b). Only until the very last half cycle of loading did a diagonal shear crack occur (marked with letter *b*). This diagonal crack did not occur at the peak loads of the earlier cycles, but after the same maximum lateral force had been reached several times.

The third test wall, W3 being a slender one, cracked entirely in flexure. A horizontal crack along the bed joint immediately above the bottom course was observed along approximately 80% of the length of the base (Fig. 3.1c). When the lateral force was reversed, the flexural crack occurred on the opposite side of the wall and was then continuous along the entire length of the wall. The ultimate limit state for specimen W3 was clearly a flexural failure that was initiated by flexural tensile cracking at the heel, but was reached when the masonry at the wall toe crushed in compression.

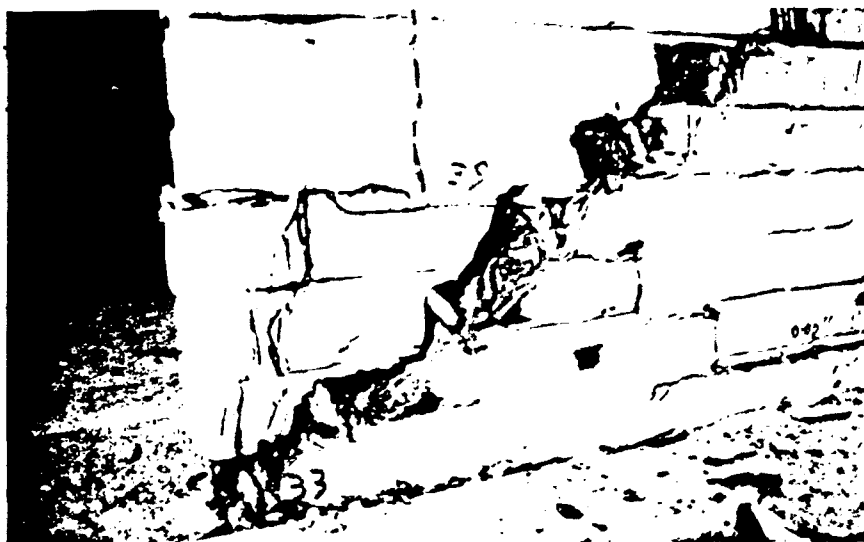
Vertical splitting cracks, and spalling of bricks was observed at the toe of specimen W2 (Fig. 3.2) much like that for a masonry prism subjected to concentric vertical compression. This condition represented the ultimate limit state of the wall. A toe compression failure such as this may be construed to be a flexural failure, however, it was precipitated by diagonal shear cracking. Thus, the limit state for specimen W2 may be classified as a flexure-shear failure.

Figure 3.2 Toe Crushing for Specimen W2

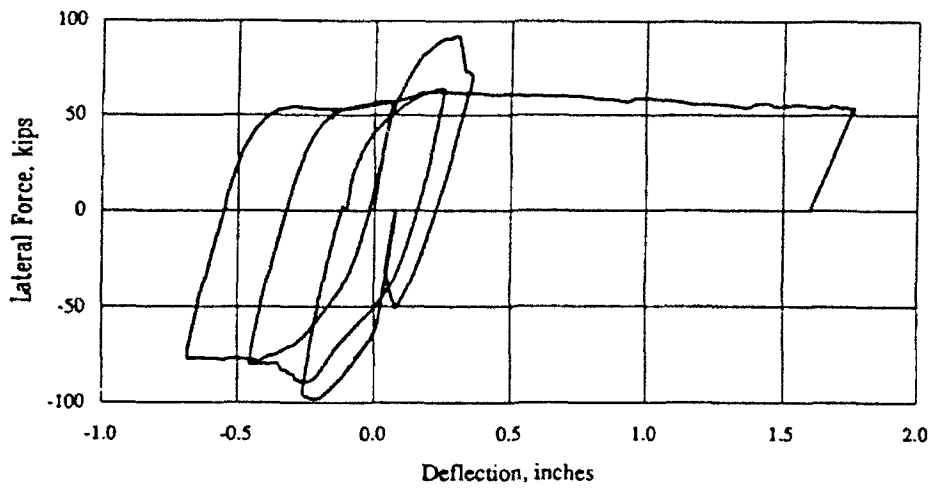
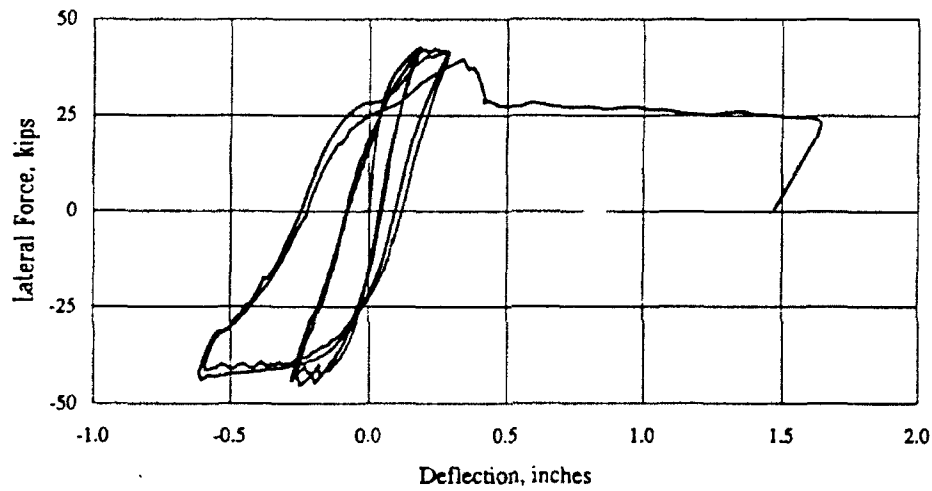
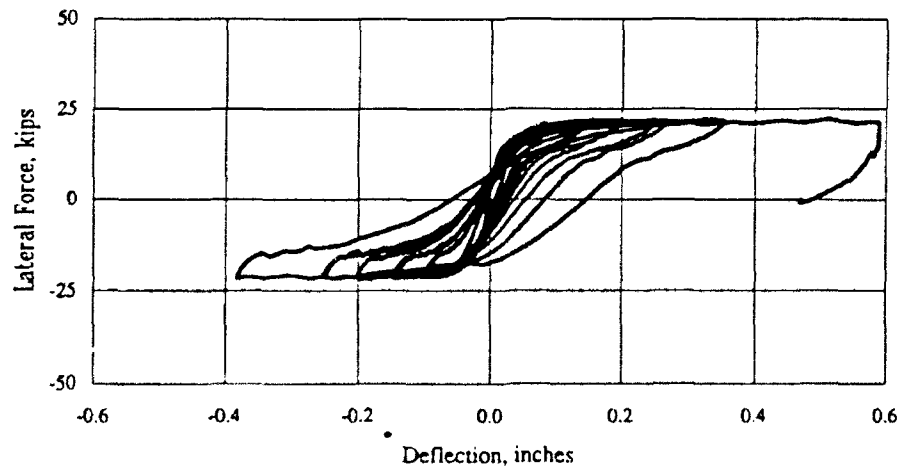
The peak strength for all three walls was as high as 1.3 times their initial cracking strength. The striking feature, however, is the fact that the walls could resist lateral force while deflecting to extremely large deflections (2% lateral drift or more). This ductile behavior had to be attributable to friction acting along the bed joints due to the constant vertical compressive stress applied to each test specimen. At very large drifts, mortar head joints were observed to be open to nearly one inch. Thus, the vertical compressive stress made a significant difference on the apparent ductility of the element.

It should be noted from the hysteresis loops for the load-deflection for all three walls that unlike a reinforced member, no change in stiffness (pinching) was observed upon reversal of the load. This is due to the fact that previously opened cracks closed soon after the deflection was

Figure 3.3 Measured Relations between Lateral Force and Deflection

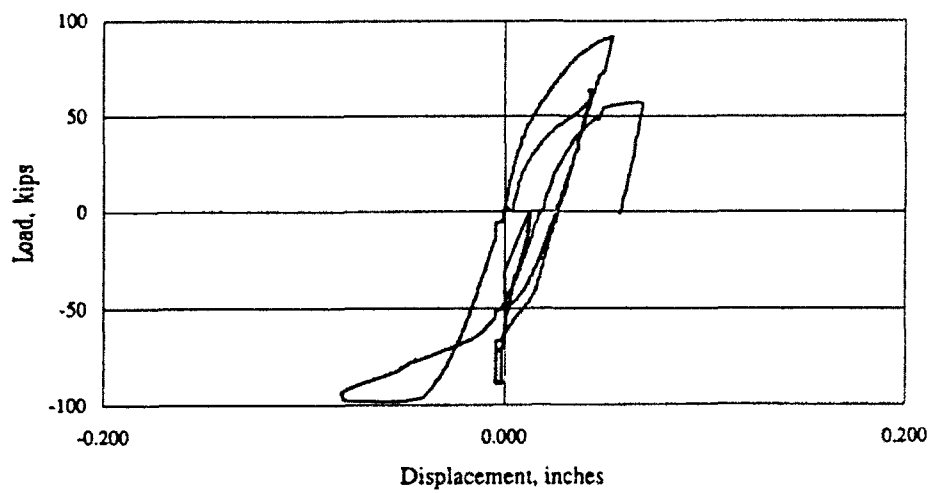
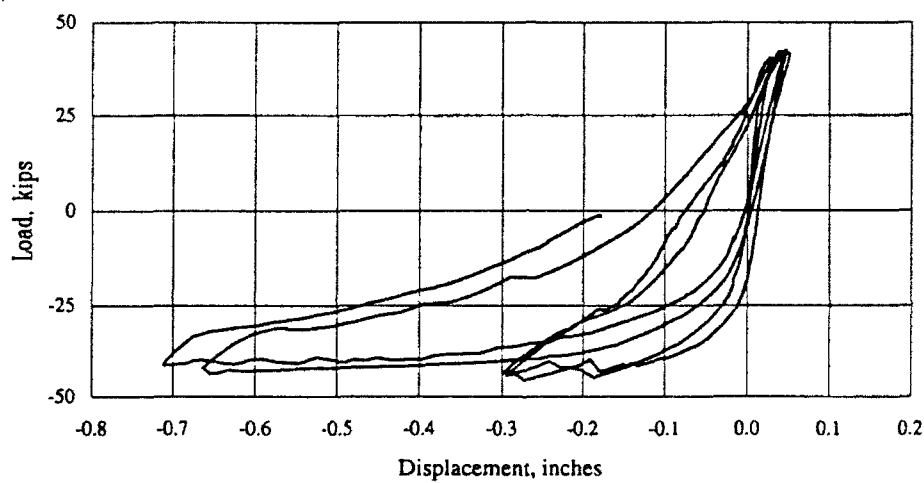
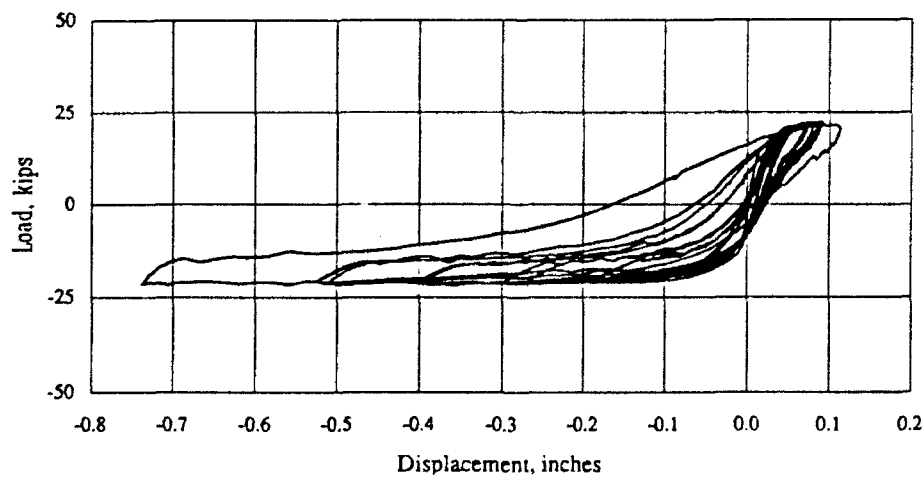
Bending moments result in vertical deformations at the heel and toe regions of a wall that many times limit the lateral strength either through tensile cracking or compressive crushing. Behavior of the test walls is therefore expressed in terms of the measured relations between lateral force and toe/heel deformation in Figs. 3.4 and 3.5. For the purpose of reporting, the *toe* region is that area which sensed compressive stress for positive loading (lateral forces to the west), and the *heel* region is that area which sensed tensile stress for positive loading. Thus, for positive loads, the *toe* region senses compressive stress which is shown as positive in the upper half of the hysteresis curves of Fig. 3.4. When the loading was reversed to a negative sense (in easterly direction), the same region is still termed the *toe* for presentation in Fig. 3.4 although in reality it acts as the *heel*. Deformations become tensile which are shown as negative on the lower half of the figure. *Heel* deformations are generally tensile for positive loadings in the upper half of Fig. 3.5, and are thus negative. Thus, the slope of the curves is generally negative. When the load reverses to a negative sense, the region senses compression and acts as the *toe*, but is still termed the *heel* for presentation in Fig. 3.5. Since the test walls and the loadings are symmetrical, the curves of Fig. 3.4 are similar to those of Fig. 3.5 if they are flipped about their horizontal axes.

Specimens W2 and W3 each cracked in flexure. The lateral force required to crack the heel region, $H_{cracked}$ in Table 3.1, can be inferred from the first change in slope of the plots of Figs. 3.4 and 3.5. These values can then be used to infer the apparent flexural tensile strength using the following common formula for summation of axial and flexural stresses.

Figure 3.4 Measured Relations between Lateral Force and Toe Deformation

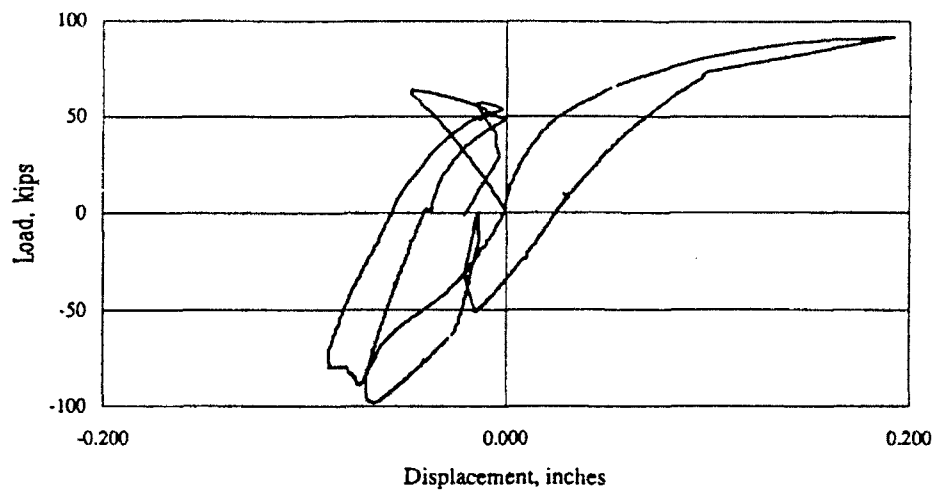
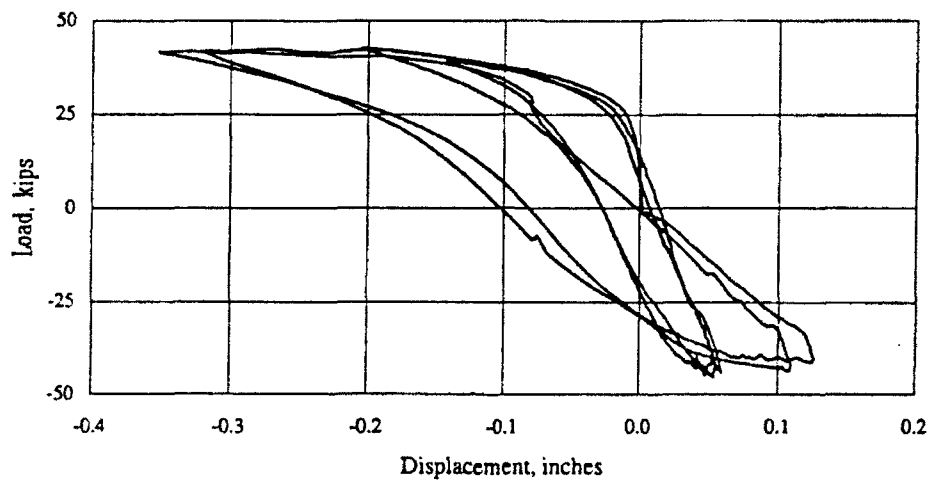
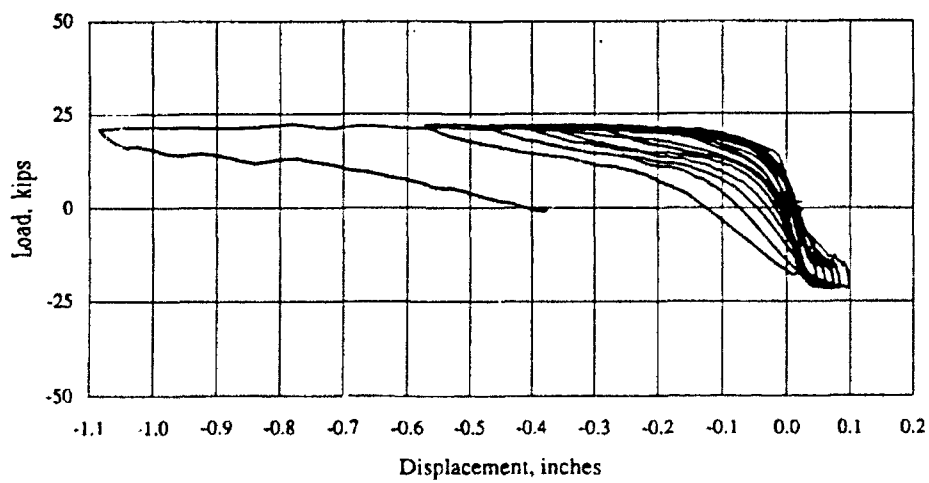
Peak vertical compressive strain for all three walls ranged from 0.003 to 0.005. These values are to be expected for crushing of masonry. During unloading, a linear relation between force and deformation was observed suggesting an elastic behavior. Cracks that had opened during loading began to close immediately after the load started to be relieved. This is surmised to be a result of the vertical compressive stress.

Figure 3.5 Measured Relation between Lateral Force and Heel Deformation

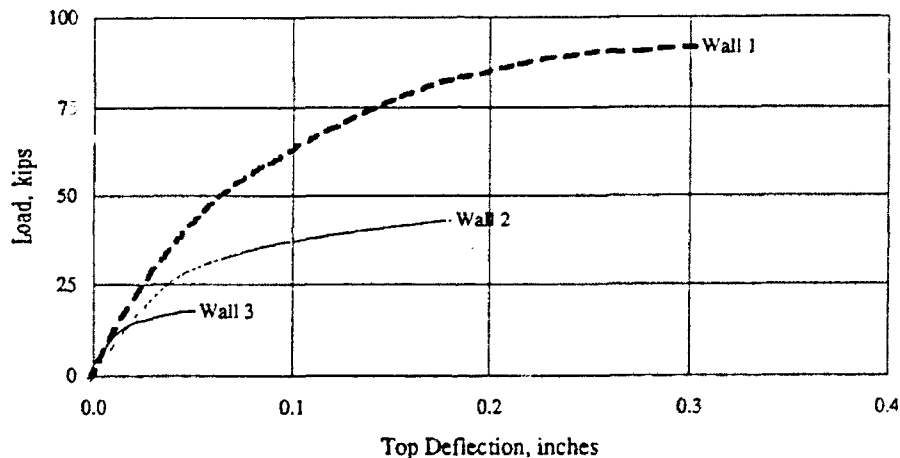
Lateral force-deflection behavior of the three wall specimens is compared in Fig. 4.1. So

Figure 4.1 Force-Deflection Behavior for the First Quarter Cycle

that direct comparisons can be made between the three curves, measured behavior is shown only for the first quarter cycle of loading. As noted in the previous chapter, wall W1 was governed by shear while walls W2 and W3 were governed by flexure. The gradual softening of wall W1 was attributable to the formation of diagonal cracks (marked with the letter *a* in Fig. 3.1). The limit on strength for W1 was the formation of the second diagonal crack (marked with the letter *b* in Fig. 3.1). The sudden changes in slope in the curves for walls W2 and W3 were attributable to flexural cracking at the heel. Peak strength for W2 was limited by diagonal cracking whereas strength for W3 was limited by toe crushing.

It should be noted that peak deflections shown in Fig. 4.1 are those that were arbitrarily set as points of unloading for the first cycle, and do not reflect absolute deformation capacity. However, the lateral deflection at which peak loads occurred are worth noting at 0.30, 0.18 and 0.08 inches for specimens W1, W2 and W3 respectively. In terms of lateral drift (deflection over wall height), these deflections are 0.42%, 0.25% and 0.08%.

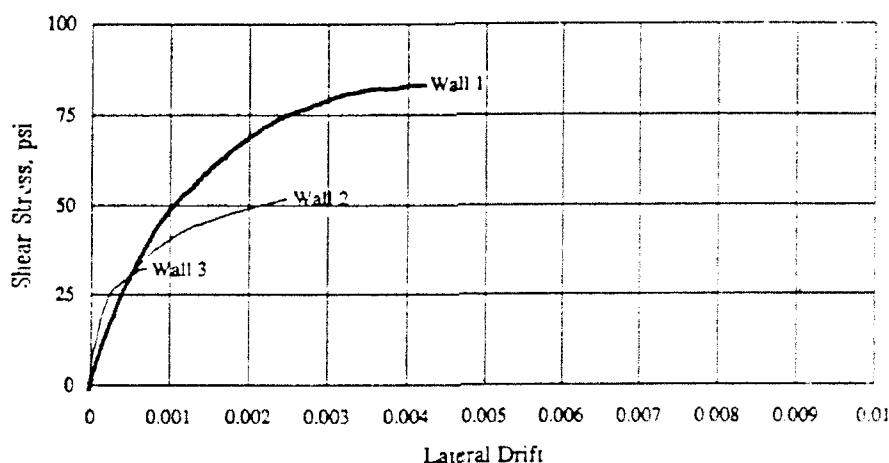
Figure 4.2 Measured Relation between Nominal Shear Stress and Lateral Drift

It is of interest to note that the initial stiffness was similar for test walls W1 and W2 when expressed as the ratio of nominal shear stress to lateral drift (Fig. 4.2). A common slope of approximately 600 psi per 1% drift was observed for these two specimens. The more slender wall, W3, had a larger normalized stiffness.

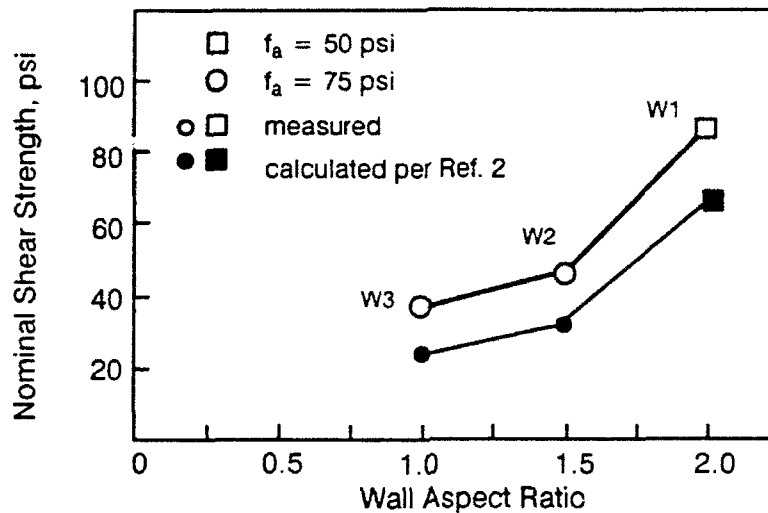
Figure 4.3 Observed Relation between Shear Strength and Wall Aspect Ratio

For purposes of comparison with the measured ultimate shear strength, f_{va} is replaced with f_{vu} by substituting f_m for F_a . The measured prism strength is 911 psi as noted in Chapter 2. Strength estimates calculated using Eq. 4.5 are plotted on Fig. 4.3 for comparison with the measured data. Whereas the strength estimates are lower, and thus conservative, they do follow the same tendency with respect to aspect ratio as the measured data. This is somewhat surprising since the formulation for Eq. 4.5 is based on a flexural mechanism, and wall W1 failed in shear.

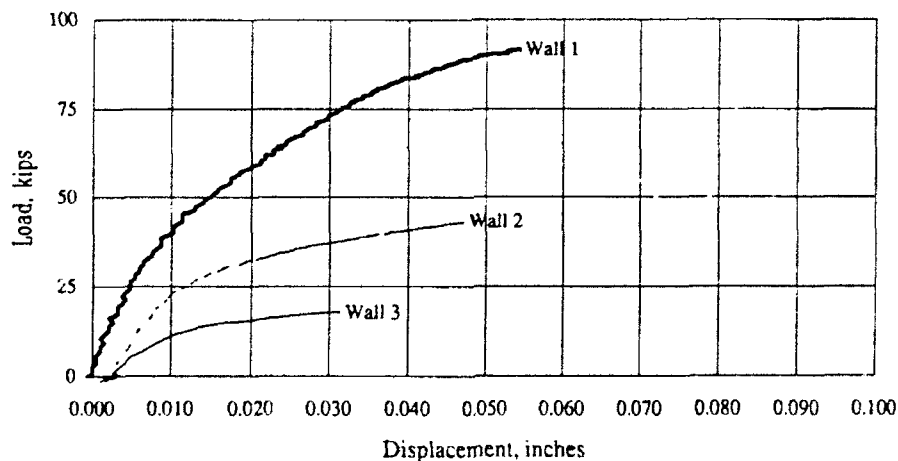
Lateral force is plotted versus toe deformation for the first quarter cycle of each test wall in Fig. 4.4. The initial value for the toe deformation for specimens W2 and W3 is a result of the

Figure 4.4 Measured Relation between Lateral Force and Toe Deformation

vertical stress that was applied after the zero transducer reading was taken which was not done for specimen W1. The peak compressive strains were on the order of 0.005 for walls W1 and W2 and 0.003 for W3. These values are within the expected range for masonry near crushing, and

correlate with the observed damage. The rather high compressive strain for wall W1 is of interest since the wall failed in shear.

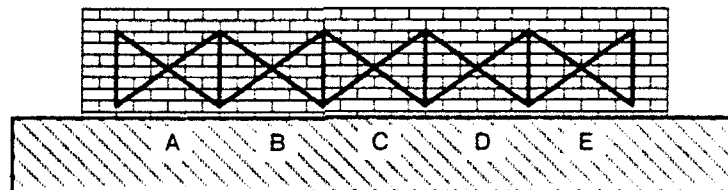
As described in Chapter 2, shear strains across five gage lengths were measured across the base of a wall specimen using the configuration of displacement transducers shown in Fig. 4.5. Readings from the two diagonal transducers were combined with readings from the two adjacent vertical transducers to give a single value for average shear strain across the gage length. A sample relation between lateral force and shear strain is shown in Fig. 4.6 to show the nature of the measurement technique. Force-strain curves for all gage points for all specimens are given in Appendix A.

Figure 4.5 Shear Distortion Measurement Locations

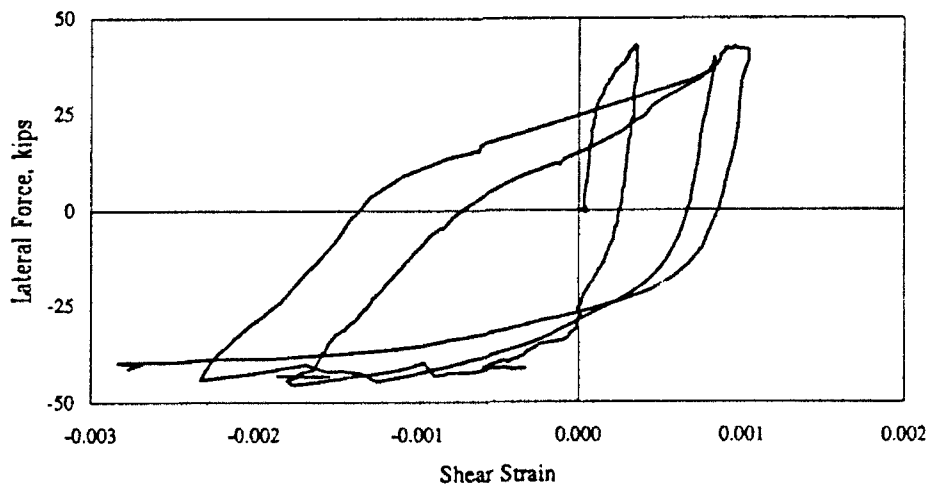
Fig. 4.6 Typical Relation between Lateral Force and Shear Strain (Specimen 2, point A)

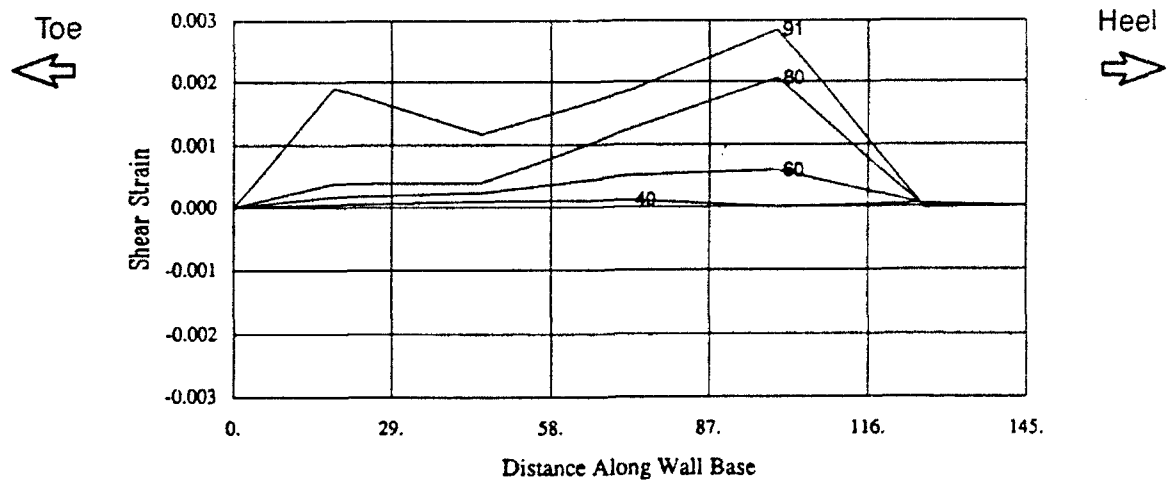
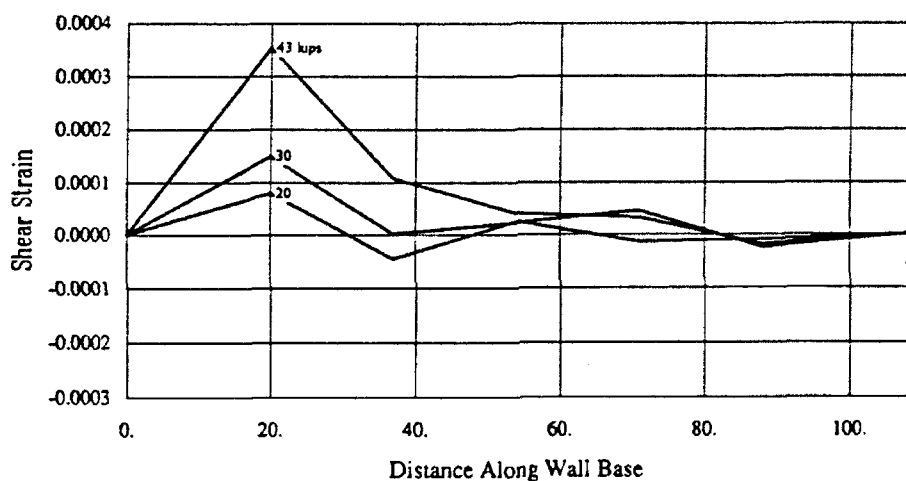
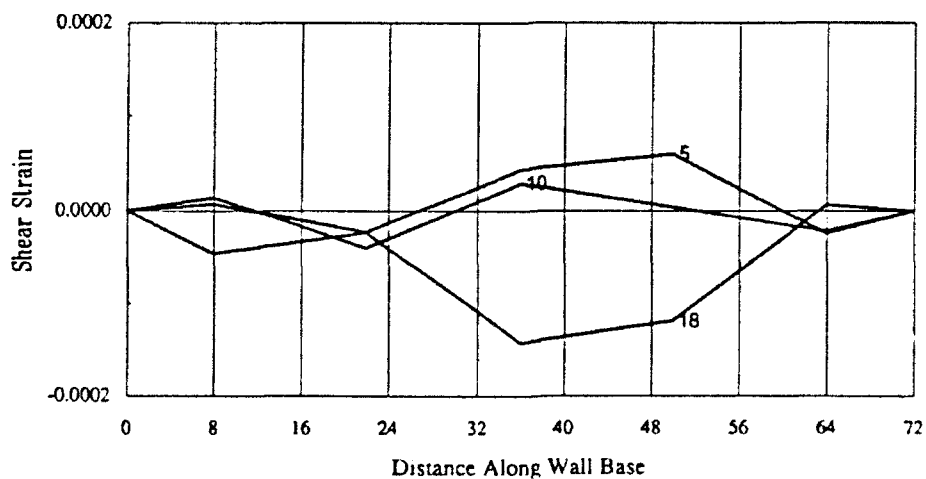
Strain measurements for all five gage points are plotted in Figs. 4.7 and 4.8 to show the apparent distribution of shear strain along the wall base. Distributions are shown for a few representative load levels during the first quarter cycle of loading in Fig. 4.7. Shear strain distributions are for loading to the west or to the left in the figure. Thus the toe region is on the left-hand side of the distribution. Curves shown in Fig. 4.8 demonstrate the nature of the distribution at first un-

Figure 4.7 Distribution of Shear Strain for the First Quarter Cycle

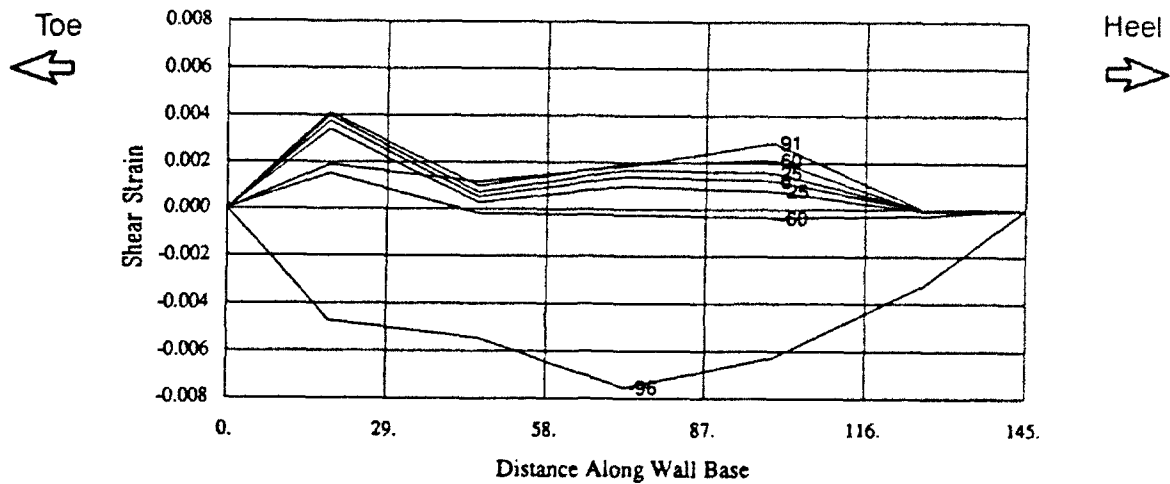
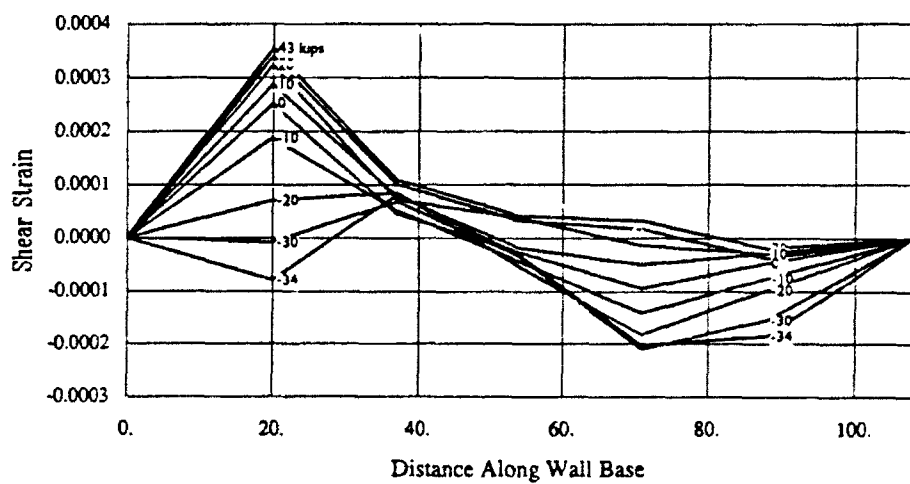
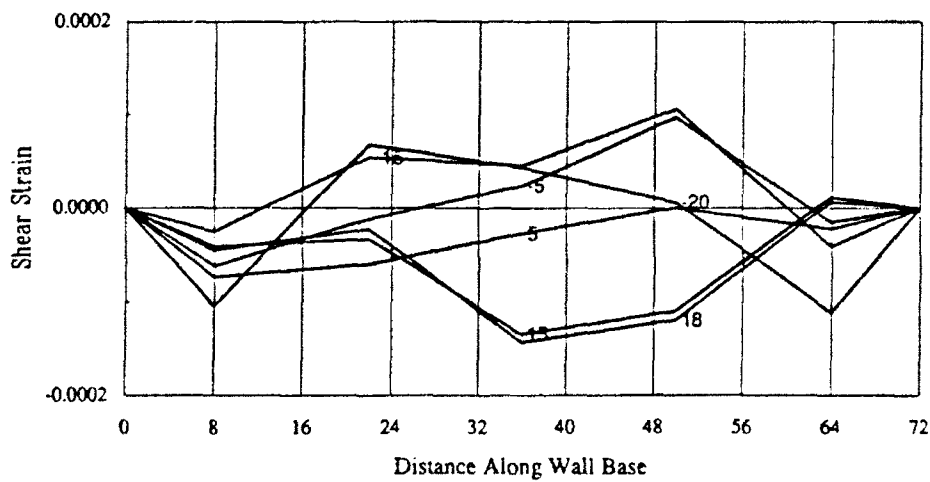
Figure 4.8 Distribution of Shear Strain for the Second and Third Quarter Cycle

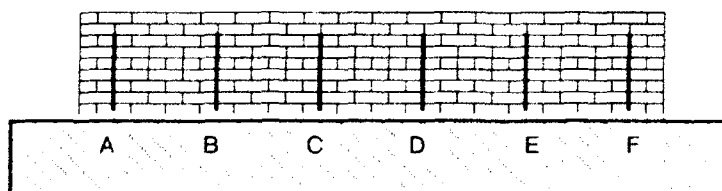
As noted in Chapter 2, vertical strain was measured at six different points along the wall base with vertical displacement transducers as shown in Fig. 4.9.

Figure 4.9 Vertical Strain Measurement Locations

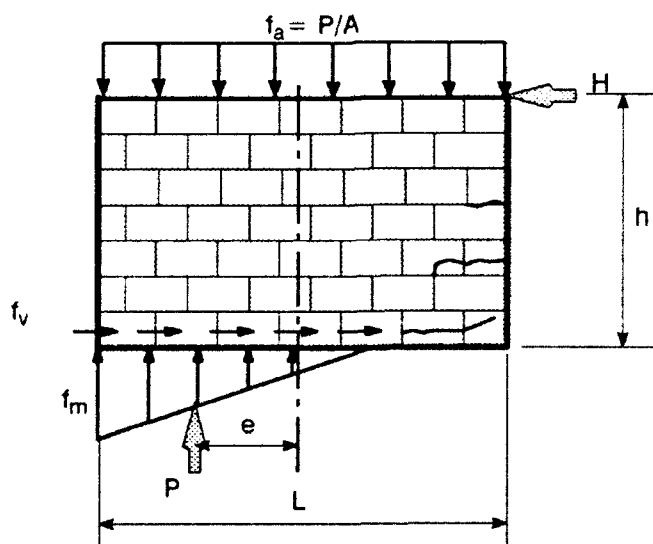
Figure 4.11. Free Body Diagram of Wall Cracked at Base.

As lateral force is increased and the flexural crack across the base of wall, the resultant of the vertical force continues to shift towards the toe until compressive stress is exceeded. Thus, an unreinforced wall with no tensile strength can resist lateral force, H , and overturning moment, Hh , through the vertical force couple that is created when the resultant force, P shifts a distance e from the centroid as depicted in Fig. 4.11.

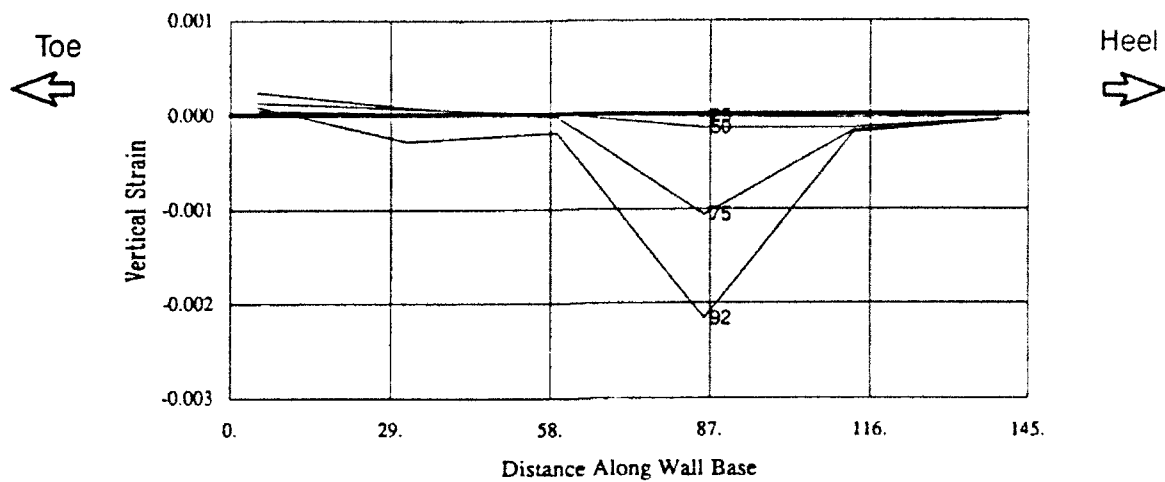
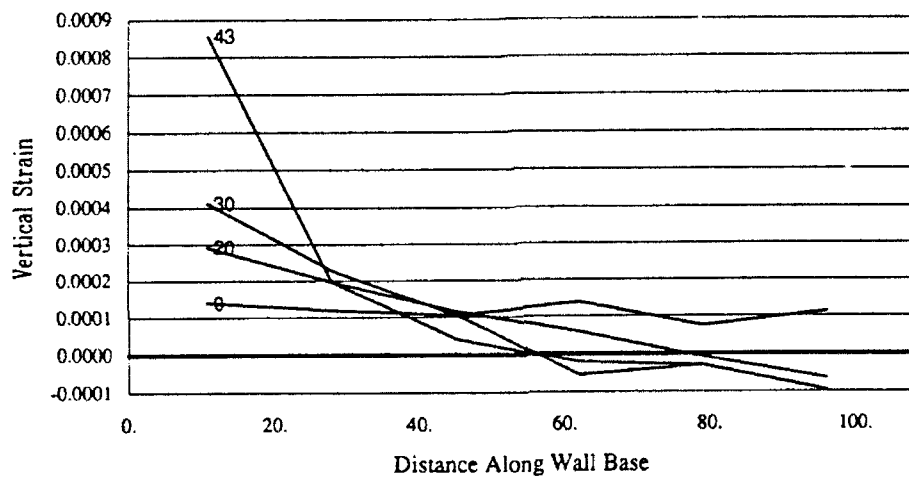
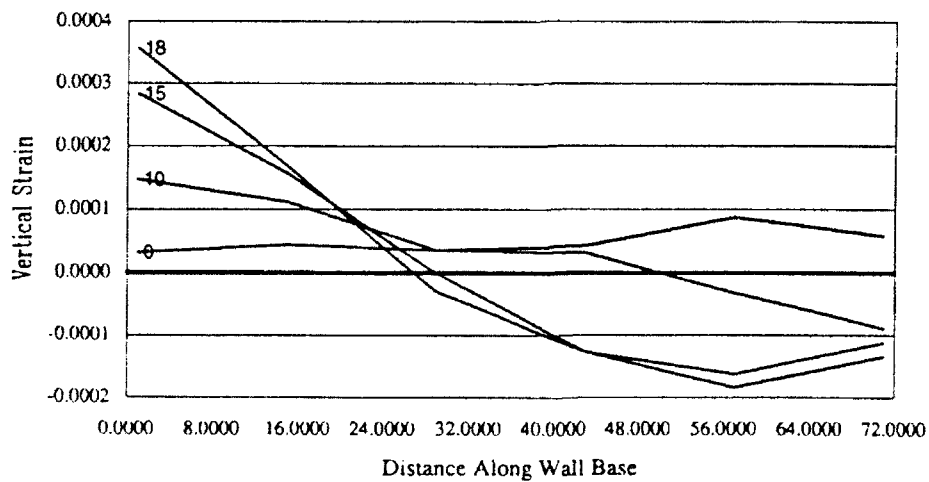
Measured relations between lateral force and strain at each point for the three wall specimens are presented in Appendix A for reference. Distributions of vertical strain for a few representative load levels during the first quarter cycle of loading is shown in Fig. 4.10 for the three specimens. Positive strain values are for compression. Loading was to the west, or to the left in the figure. It is clear that each wall specimen was sensing compression at the toe region (on the left hand side) and tension at the heel region, as would be expected. The location of the neutral axis could also be inferred from the distributions.

Vertical strain distributions for walls W2 and W3 clearly indicate that the neutral axis was shifting towards the toe (to the left in Fig. 4.10) as the lateral force was increased. This finding is in agreement with the observed crack development along the base of each wall. The distribution of vertical compressive strain is nearly linear suggesting that the masonry was behaving as a linear material, and that a simple triangular stress distribution (as commonly assumed) would be admissible. Compressive strain at the toe is seen to increase disproportionately with lateral force as would be expected as the uncracked compression zone continues to shrink. This finding strongly suggests that the ultimate limit state for flexural action is toe crushing and not tensile cracking.

Figure 4.10 Distribution of Vertical Strain for the First Quarter Cycle

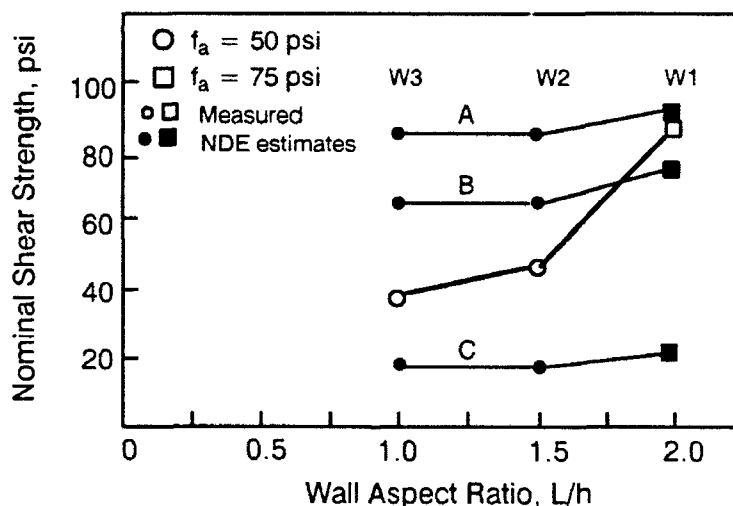
shear estimates (shown in Column A of table) represents the most direct comparison with the test data. The shove test measurements are simply divided by a 1.5 factor to account for the difference between average and maximum shear stress. In this case, average shove test values, v'_u , are used with no corrections for vertical stress since the identical vertical stress was applied during the shove test as was used during the ultimate load test (values of v'_u were read from the line given in Fig. 2.10). Thus, no assumptions of frictional coefficients need to be made. Also, because no safety factors are applied, ultimate shove test values can be compared directly with ultimate wall shear stresses.

Figure 4.12 Wall Shear Strength vs. Aspect Ratio

Values in Column A are always larger than the measured strengths suggesting that the NDE method is on the unconservative side. For wall specimen W1 which failed in shear with no flexural cracking, the correlation with the measured shear strength (85 vs. 91 psi) is quite close. For the other two wall specimens, W2 and W3, whose behavior was governed by flexural cracking, the actual strength fell far below the estimate (36 vs 83 psi for W3). The deviation between measured and estimated strengths became larger as the L/h aspect ratio reduced. The difference may be

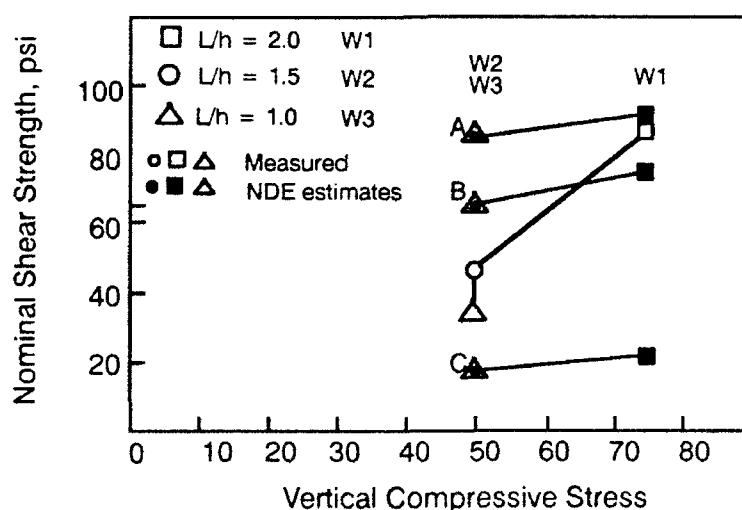
Figure 4.13 Wall Shear Strength vs. Vertical Compressive Stress

By examining Fig. 4.13, it is apparent that there is a larger decrease in shear strength as a result of decreasing vertical compressive stress than the code formulas express. Also, there is a decrease in shear strength attributable to the aspect ratio, L/h , that the code approach neglects. For the same vertical compressive stress (50 psi) specimen W3 had a smaller shear strength than specimen W2. This is again a result of the influence of flexural cracking on shear transfer.

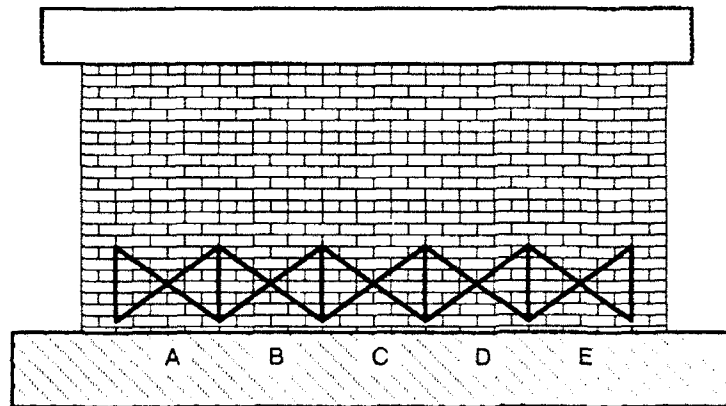
As noted in Chapters 2 and 4, shear strain was deduced from the series of five sets of diagonal and vertical displacement transducers shown in Fig. A.1. Shear strain was computed using signals from two diagonal and the two adjacent vertical transducers using Eq. 2.1. These shear strains represent an average of the shear strains across the gage length, and are used to plot the distributions shown in Figs. 4.7 and 4.8. On the following pages of this appendix, the measured relations between lateral force and shear strains at individual points (A through E) are given as reference material.

Figure A.1 Shear Distortion Measurement Locations
